**DEPARTMENT OF TRANSPORTATION**

Office of Structural Materials

Contract #: 04-0120F4Cty: SF/ALA Rte: 80 PM: 13.2/13.9File #: 69.28**WELDING INSPECTION REPORT****Resident Engineer:**Siegenthaler, Peter**Address:** 333 Burma Road**City:** Oakland, CA 94607**Report No:** WIR-026908**Date Inspected:** 09-Aug-2011**Project Name:** SAS Superstructure**OSM Arrival Time:** 700**Prime Contractor:** American Bridge/Fluor Enterprises, a JV**OSM Departure Time:** 1900**Contractor:** Zhenhua Port Machinery Company, Ltd (ZPMC), Changxing Island **Location:** Shanghai, China**CWI Name:** Shigang/Jun**CWI Present:** Yes No**Inspected CWI report:** Yes No N/A**Rod Oven in Use:** Yes No N/A**Electrode to specification:** Yes No N/A**Weld Procedures Followed:** Yes No N/A**Qualified Welders:** Yes No N/A**Verified Joint Fit-up:** Yes No N/A**Approved Drawings:** Yes No N/A**Approved WPS:** Yes No N/A**Delayed / Cancelled:** Yes No N/A**Bridge No:** 34-0006**Component:** OBG Bike Path**Summary of Items Observed:**

# WELDING INSPECTION REPORT

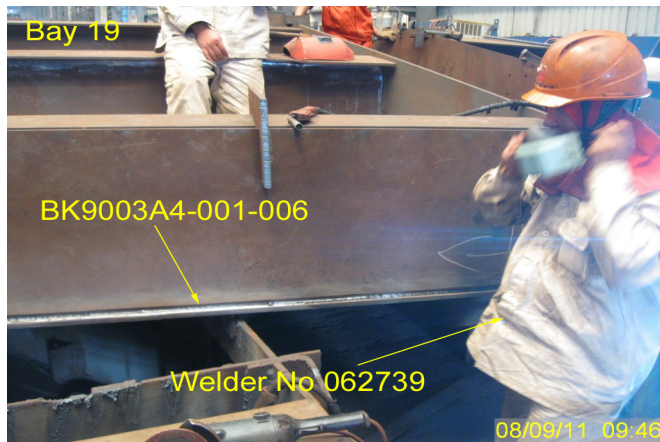
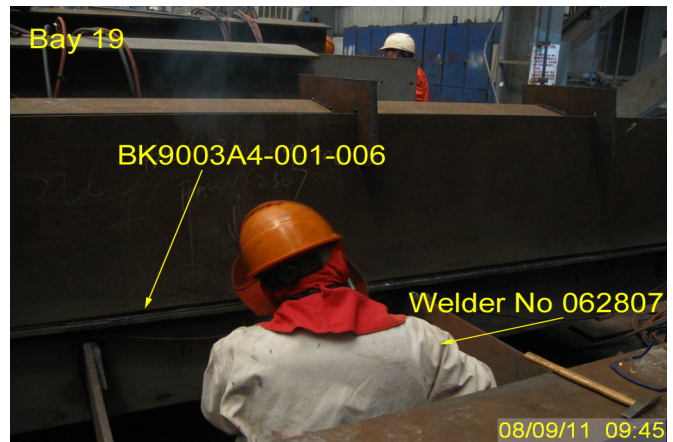
This QA Inspector observed the following work in progress: FCAW welding of weld joint 006 located on BK9003A4-001. Welder is identified as 062739. ZPMC Quality Control (QC) is identified as Peng Wen Jun. The welding variables recorded by QC appeared to comply with the Applicable WPS.

This QA Inspector observed the following work in progress: FCAW welding of weld joint 006 located on BK9003A4-001. Welder is identified as 062807. ZPMC Quality Control (QC) is identified as Peng Wen Jun. The welding variables recorded by QC appeared to comply with the Applicable WPS.

Unless otherwise noted, all work observed on this date appeared to generally comply with applicable contract documents.
